NAVSHIPS 0967-066-7190

ELECTRONICS FIELD CHANGE BULLETIN
NAVAL SHIP SYSTEMS COMMAND
DEPARTMENT OF THE NAVY
WASHINGTON, D.C. 20360

12-, 15-, 16-, 18-, 19-, 20-, 21-, 22-AN/URC-32
1-, 4-, 5-, 6-, 7-AN/URC-32A
2-, 3-, 4-AN/URC-32B
3-, 6-, 7-, 9-, 10-, 11-, 12-, 13-KWT-6 (8)

PREPARED BY THE NAVAL SHIP ENGINEERING CENTER, CODE 6181C

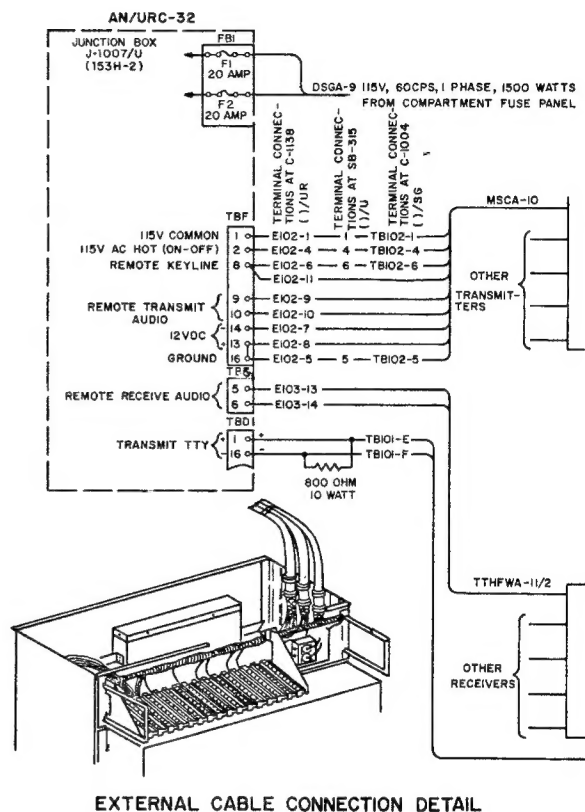
Figure 1.

Difficulty has been experienced aboard ship when paralleling the AN/URC-32 with another receiver through the audio patch panel. When the AN/URC-32 receiver is switched in, the audio from the other receiver is blanked out. This difficulty is caused by using the 4 ohm output from the AN/URC-32 series of equipments.

EXTERNAL CABLE CONNECTION DETAIL

1. Remove cover from junction box.
2. Replace the 680 ohm resistor connected across contacts 5 and 6 of terminal board "G" with an 1800 ohm 2 watt resistor.
3. Connect audio cable to remote system on contacts 5 and 6 of terminal board "G" instead of Contacts 11 and 12 on terminal board "F".

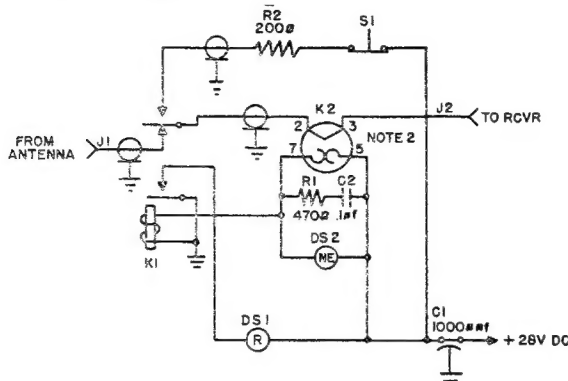
Figure 1. Receiver overload protective device before field change.

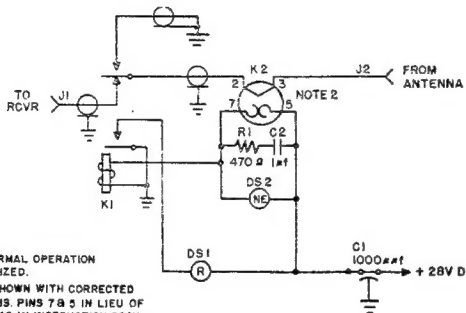
Figure 2. Receiver overload protective device after field change.

NOTES:
1. SHOWN IN NORMAL OPERATION
K1 IS ENERGIZED.
2. RELAY K2 SHOWN WITH CORRECTED
CONNECTIONS. PINS 7 & 5 IN LIEU OF
PINS 7 & 4 AS IN INSTRUCTION BOOK.

4. Remove the coaxial lead connected between relay (K1) and resistor (R2) (200 ohms, 5 W, 5 percent).

5. Shorten the coaxial cable, removed in step 4, to within 1 inch of the BNC connector. Remove 1/2 inch of the outer insulation. Push the braided shield back and remove 3/8 inch of the dielectric from the center conductor. Pull the shield over the conductor and solder the conductor and shield together.

6. Connect the grounded BNC connector to K1 as removed in step 4. Replace bottom cover.
7. Stencil "ANTENNA INPUT" adjacent to J2. Stencil "TO RECEIVER" adjacent to J1.
8. Reinstall the protective device in the AN/URC-32. Connect leads removed in step 2 (Cable W-27 or antenna cable will connect to J2, Cable W-3 will connect to J1).
9. Return equipment to normal operation.

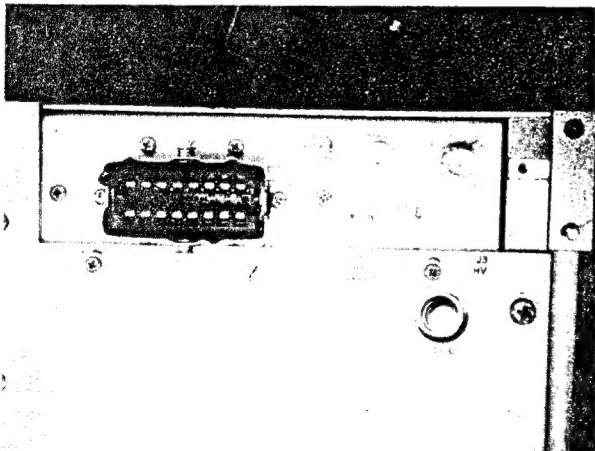
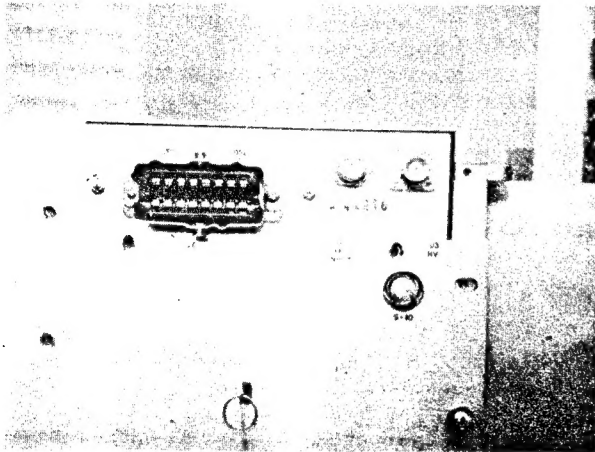
The purpose of this field change is to provide dissimilar receptacles and plugs which will prevent the inadvertent reversal of the RF input plug, 15W2P1, and high voltage plug, 15W9P1, in the Radio Frequency Amplifier, AM-2061/URT.

Figure 1. Modification performed.

5. Remove 2J1, R.F. input receptacle, type UG-931/U, from the mounting bracket. NOTE: 2J1 is the center connector on the mounting bracket (see figure 1).

7. Assemble the new, DAGE No. 8009-1, connector on the coaxial cable.

8. Install the new connector, DAGE No. 8009-1, on the mounting bracket.
